Evaluation of Medium and High Voltage Machines with

Motor Circuit

ANALYSIS

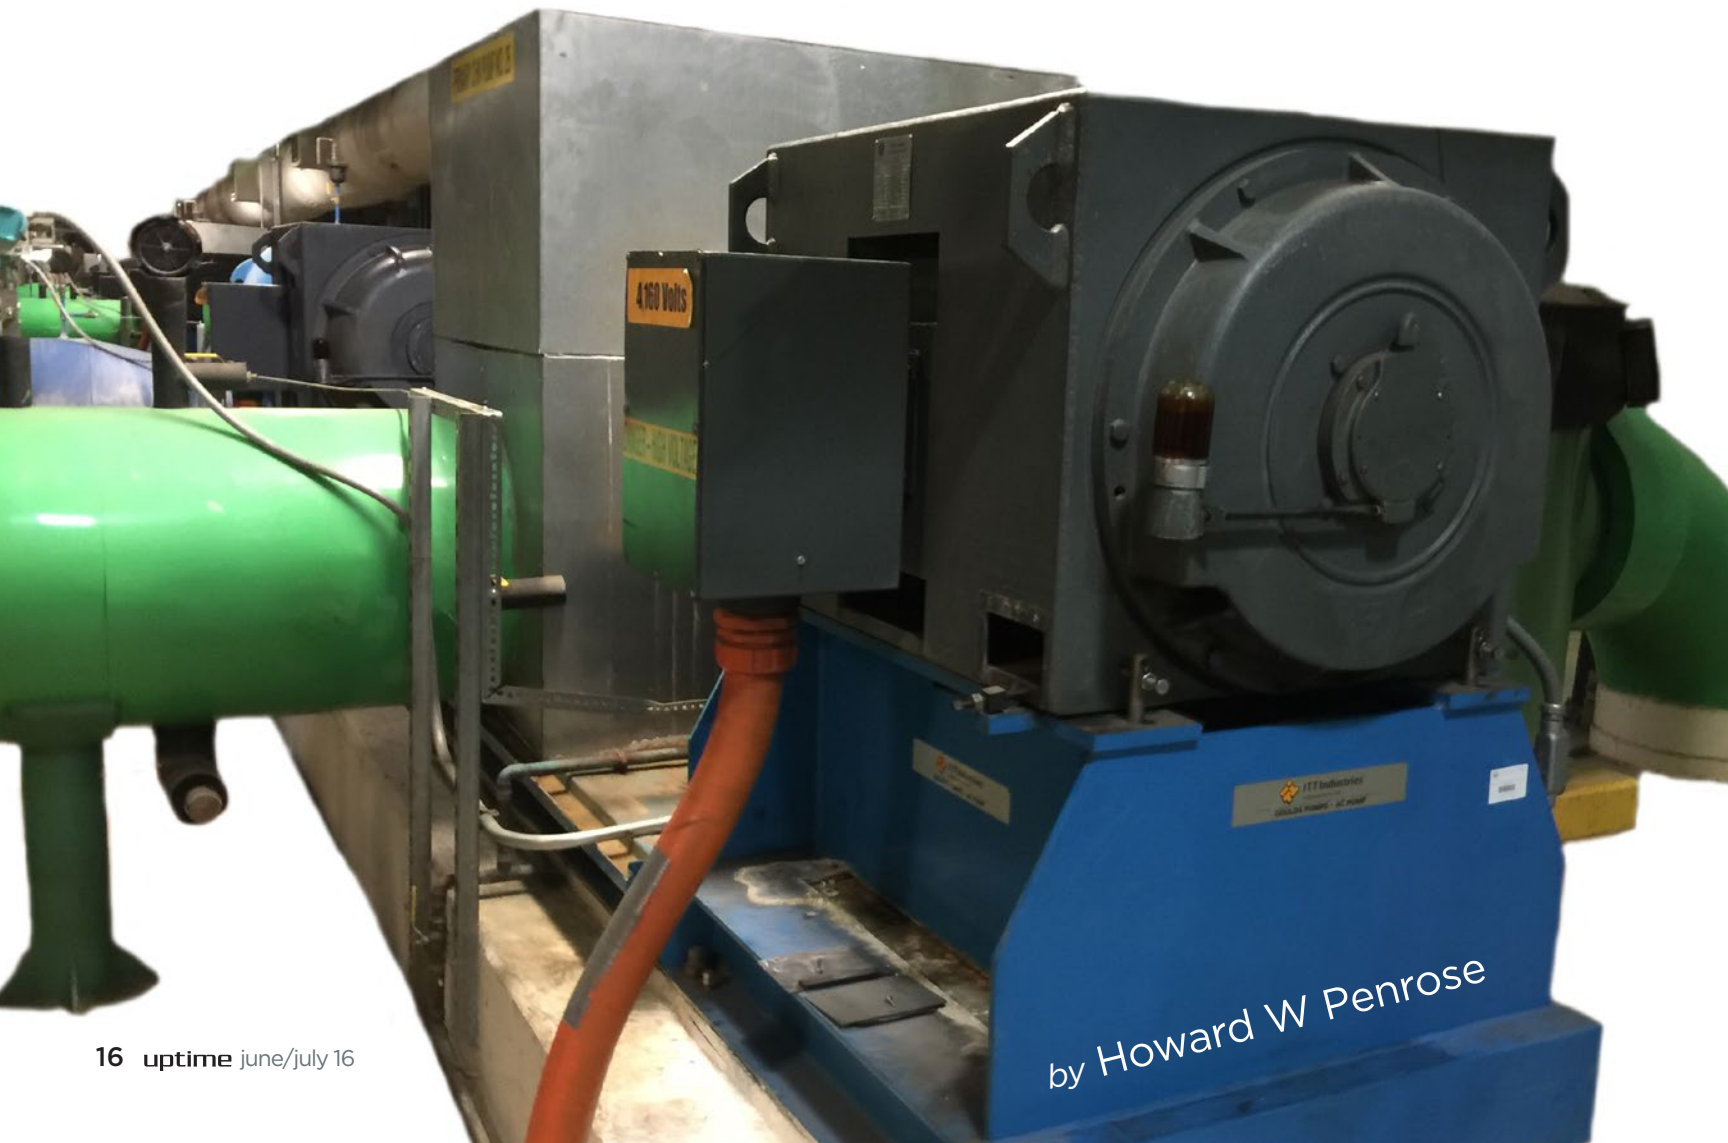
← **Figure 1:** A 300 horsepower, 885 RPM, 4160 Vac, form wound motor

The first machine evaluated was an ODP 300 horsepower, 885 RPM, 4160 Vac, form wound electric motor that had some visual level of contamination. While no specific test results indicated the contamination was an issue, the unbalanced partial discharge (PD) levels may be an early indicator of insulation degradation.

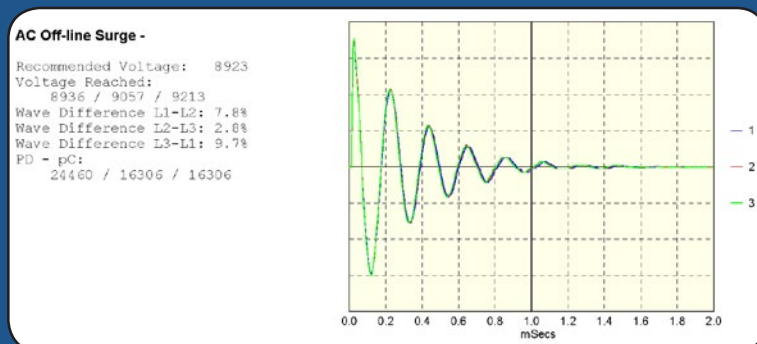
Figure 2: Surge comparison test and PD test of the 300 horsepower motor

Table 2 and Figure 2 are the low voltage and high voltage MCA tests. The data was balanced with the exception of PD, which was measured in picocoulombs and unbalanced. Off-line PD tests involve trending and/or comparison of phases or like motors to determine if there are changes or unbalances. In this case, the average PD from other machines was under 20,000 pC and relatively balanced. Therefore, it was determined that a polarization index and insulation resistance profile (IRP) reading would be performed. The motor also passed a surge test, indicating that any issues are early in nature and should be trended, or the motor should be removed, cleaned and put through a short cycle vacuum pressure impregnation (VPI) to fill in any cracks or surface voids.

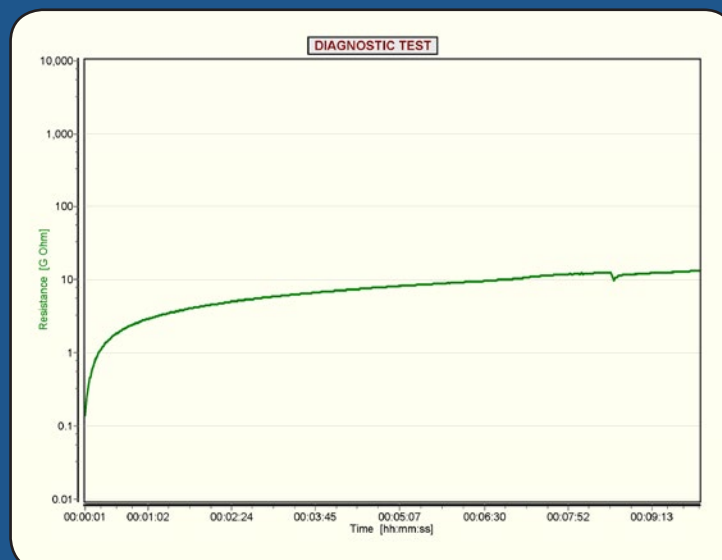
Figure 3: IRP with small discharges starting at about seven minutes, indicating an aging insulation system

The IRP was performed at 2500 Vdc and resulted in only a few small capacitive discharges. Therefore, the final conclusion was to plan an overhaul within the next three to six months.

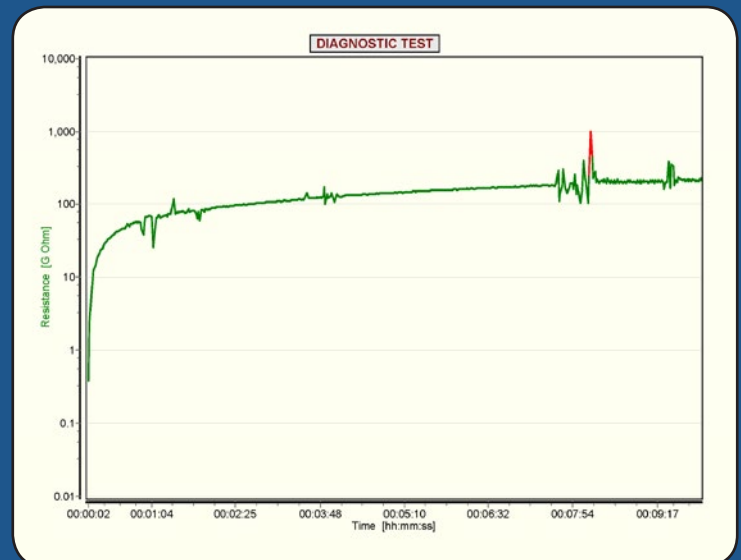
Figure 6: Rotor four months later after the motor was idle for several weeks

The increase in discharges in Figures 5, 6 and 7 indicates the synchronous motor rotor is rapidly decaying. The reasons for degradation were found following the second round of testing, with those findings outside the scope of this article.
